FRANKLIN AID

Franklin Application/Installation Data (AID)... For The Professional Pump Installer and Driller

Issue 3 AU-NZ January/February 2009

LIGHTNING – Submersible Motor Nemesis?

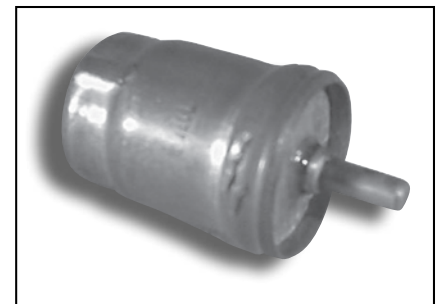
Franklin Electric's exclusive built-in lightning arrester protects against lightning induced surge damage.

These arrestors momentarily arc over to short potentially damaging surges to the shell at voltage level below that which would damage a normal motor. They then return to an open circuit after the surge is gone. Many years
