FRANKLIN AID

Franklin Application/Installation Data (AID)... For The Professional Pump Installer and Driller

Issue 3 AU-NZ January/February 2009

LIGHTNING – Submersible Motor Nemesis?

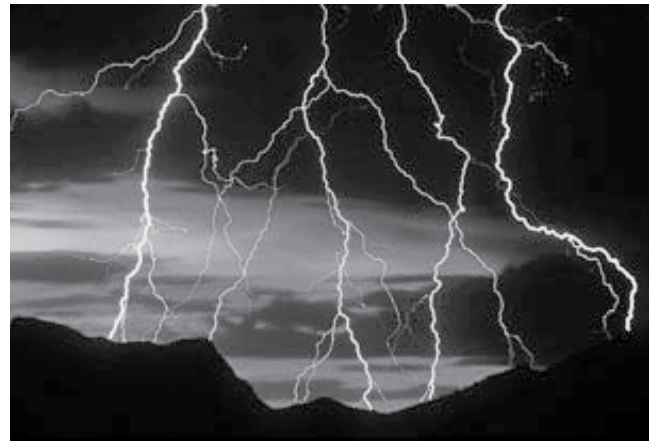
A motor that has been damaged by lightning could exhibit zero resistance to earth, infinite resistance to earth, or even a multi-thousand ohm resistance reading to earth – this type of reading could well be due to “carbon tracking” effects.

A carbon track is a carbonisation of the motor winding insulation (a small “hole” thru the winding insulation) caused by a high voltage surge. If the motor is running

at the time of the surge, the normal running current of the motor will follow thru the hole and continue to arc, increasing the damage to the insulation and immediately disabling the motor. If the motor is not running, the very small hole punched thru the motor insulation will at once weaken the strength of the insulation, then may gradually enlarge as later, smaller, more frequent surges strike. Eventually the build-up of the carbon track thru the hold in the insulation forms an electrical conduction path to the outside motor frame, and motor failure occurs.
